Special Report 81-31

December 1981

ROOF MOISTURE SURVEY: RESERVE CENTER
GARAGE, GRENIER FIELD, MANCHESTER, N.H.

Prepared for
DIRECTORATE OF FACILITIES AND HOUSING
FORT DEVENS, MASSACHUSETTS
By

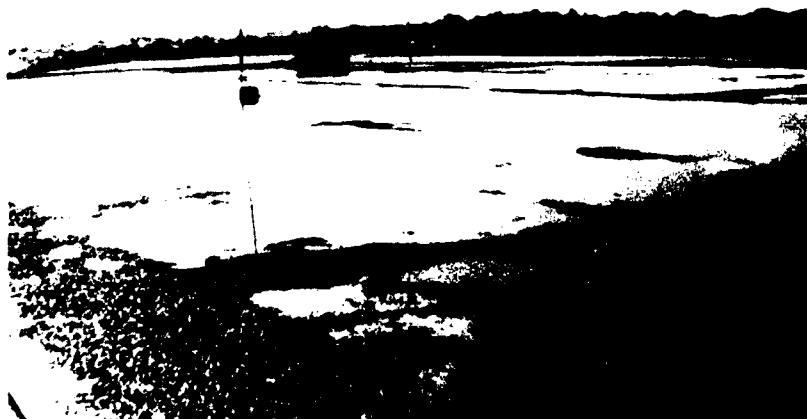
Figure 1. Ponds on the flat roof of the Reserve Center garage, June 1979.

The lack of internal drains on the main roof and the apparent lack of slope to drain cause water to pond over most of the roof, as shown in Figure 1. When water is allowed to pond on a roof the risk of premature failure is greatly increased. If this roof had been sloped to drain, much less water would have entered the insulation through membrane and flashing flaws.

1. Remove the existing membrane and insulation.
2. Repair the existing vapor retarder or install a new one towards the warm side of the roofing system.
3. Install internal drains on the main roof. Internal drains are expensive in a retrofit operation, but they are much preferred to over-the-eaves drainage for low-slope roofs in areas where it snows. Ice dams at the eaves can cause significant ponding loads on low-slope roofs in such areas.
4. On the main roof provide a positive slope to drain, of about 1/4 in./ft, using either tapered insulation or a wet fill. Use crickets in valleys to assure lateral flow of water to the drains.
5. Install curbs on which the antenna and guy wire anchors can be located, or side-mount the antenna on an exterior wall.
6. Install new insulation and a new membrane.

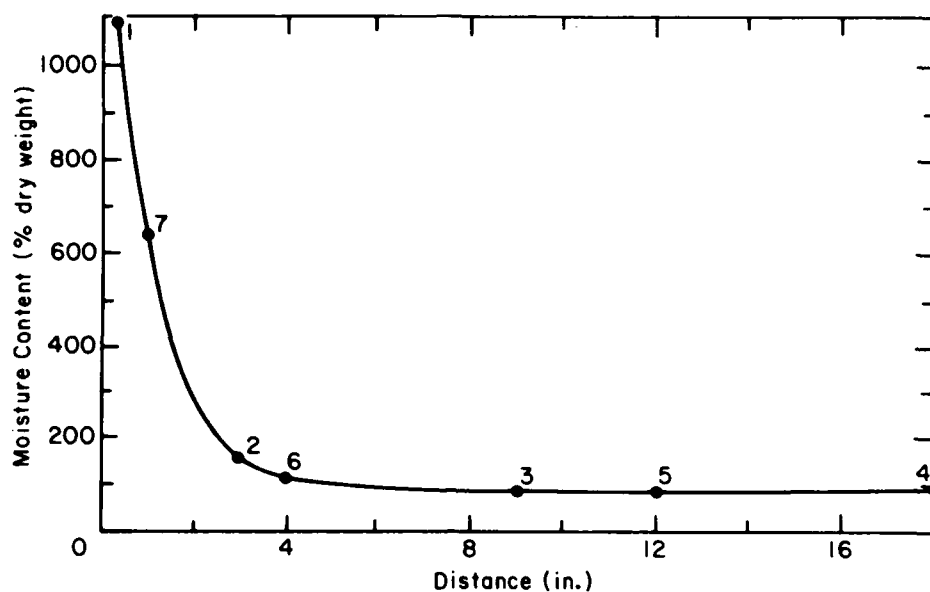
Figures 12 and 13 show a thermogram and photograph, respectively, of another area where a well-defined board outline was present. Samples of the urethane insulation were taken where shown in Figure 13 to determine the variation of moisture content with distance from the edge of the board. These samples were knife-cut cubes about 1-1/2 in. on a side. Their moisture contents are presented in Table 3. Figure 14 shows that extra moisture was concentrated near the edges of the board. This created the dramatic thermal outlines shown in Figure 9 and 12.

Figure 14. Variation of moisture content in urethane insulation with distance from edge of board.
